**PRESERVATION NEEDS ASSESSMENT**

**BENDIGO HISTORICAL SOCIETY  
COLLECTION**

**SEPTEMBER 2008**

**COMPILED BY**  
**ARTIFACT CONSERVATION**  
**74 PIPER STREET**  
**KYNETON 3444**  
**Tel. 03-5422 6606**

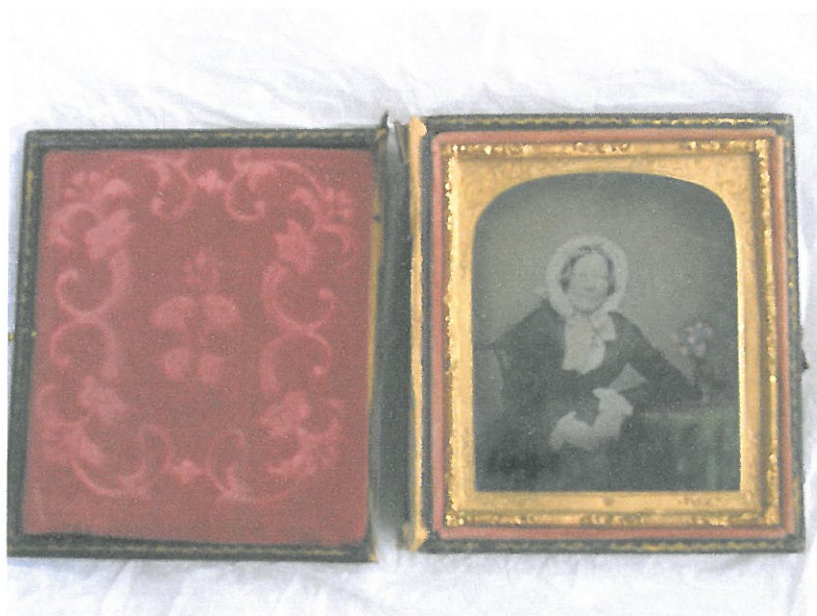
Early Daguerreotype photograph showing material types such as leather, brass, tin, paper, board, gold, glass, pigments and velvet cloth

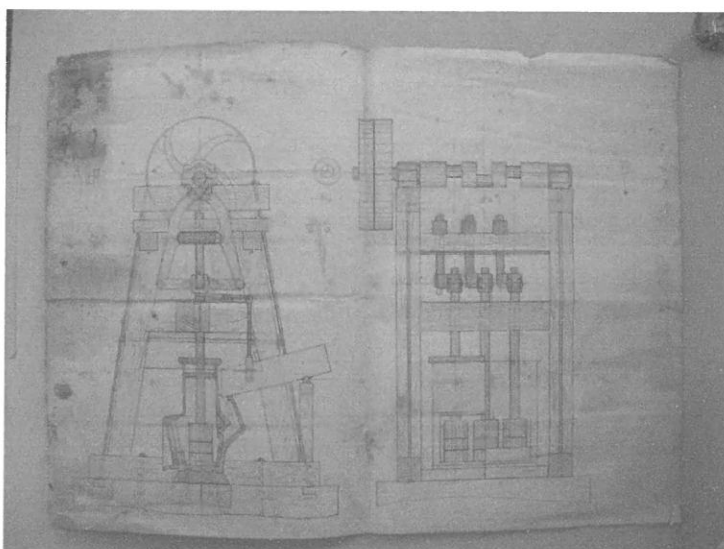
Drawing showing mould contamination, spotting, and acid burn due to poor housing

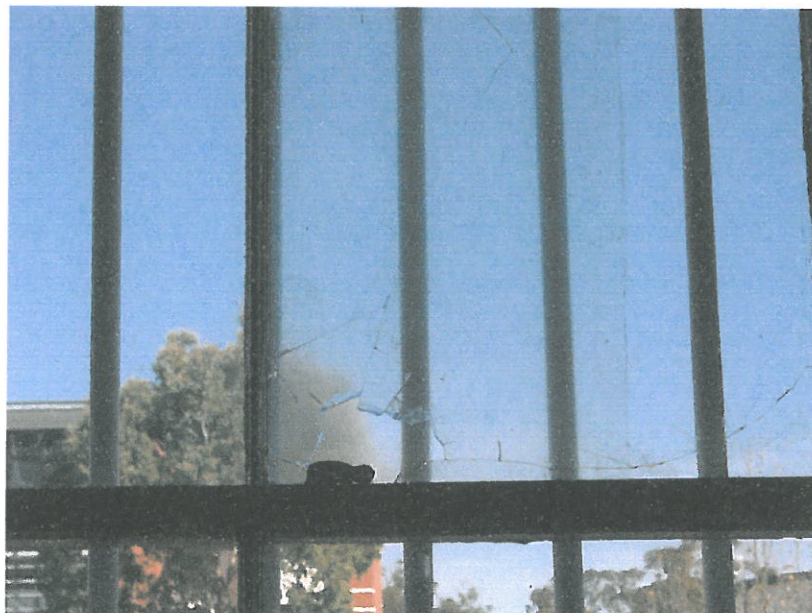
This photograph shows damage to the Governors building from a projectile thrown from outside. Several windows throughout the complex showed such damage.

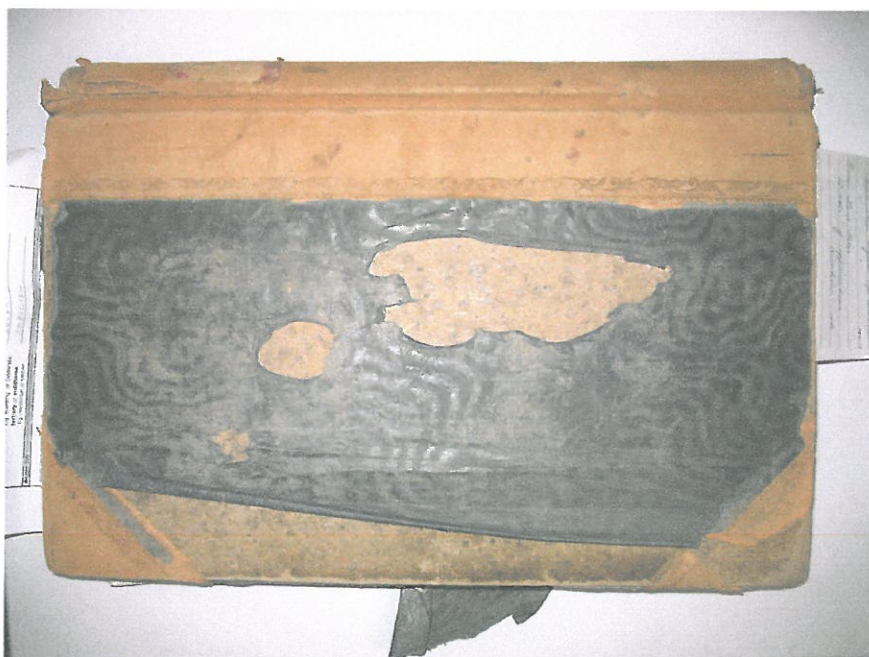
We see major chemical deterioration of the covering leather on most pre 1930 books, as well as abrasion damage to the buckram and paper covering of boards.

Account style half leather binding showing leather deterioration and damaged binding structure. Over 200 books are in this state of deterioration

- Refurbish all books, clean and complete small repairs
- Tie up books which have detached covers with cotton tape so as to retain with the book until conservation treatment
- Have culturally significant books conserved
- Have sticky numbering labels removed from spines (consult a conservator)

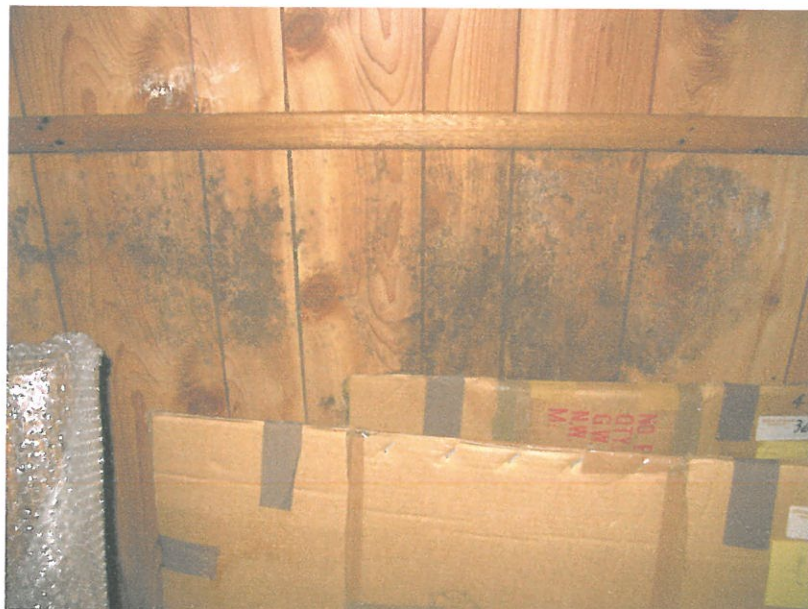
**\*Many artworks and photographs are in serious threat of damage due to active mould in the cell storage area. Mould was present on a number of items with evidence of ongoing activity and dampness in the storage area. The artworks must be removed immediately to a dry area.**

Active mould on the walls of artwork storage area. Items held are also affected.

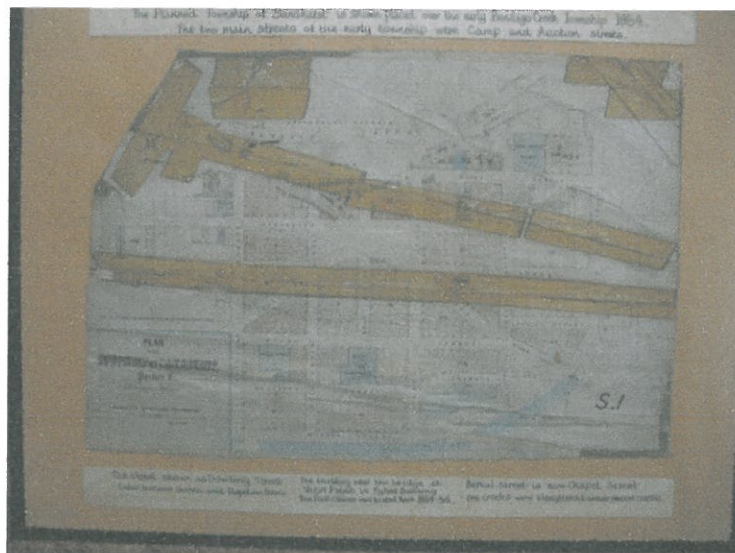
Map glued to acidic board, Sellotape repairs, crease and tears

- Dry clean all items to remove surface dirt.
- Treat items for chemical deterioration and repair tears.
- Remove metal staples, pins, paper clips, ribbon, Sellotape.
- Dispose of non archival enclosures and envelopes.
- House most important items in polypropylene enclosures and sleeves.
- Dispose of unrelated material and photocopies.

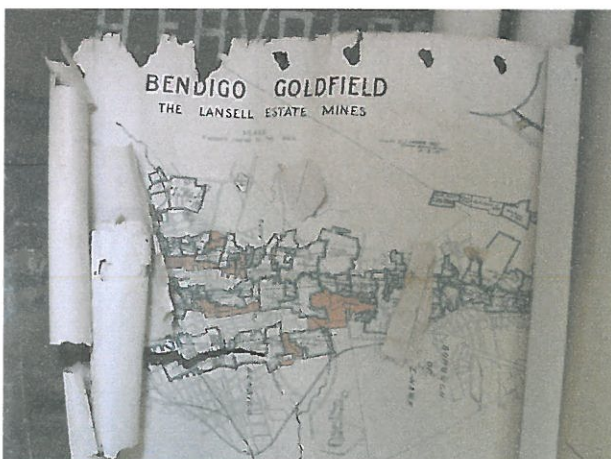
Map, note rolling & rodent damage

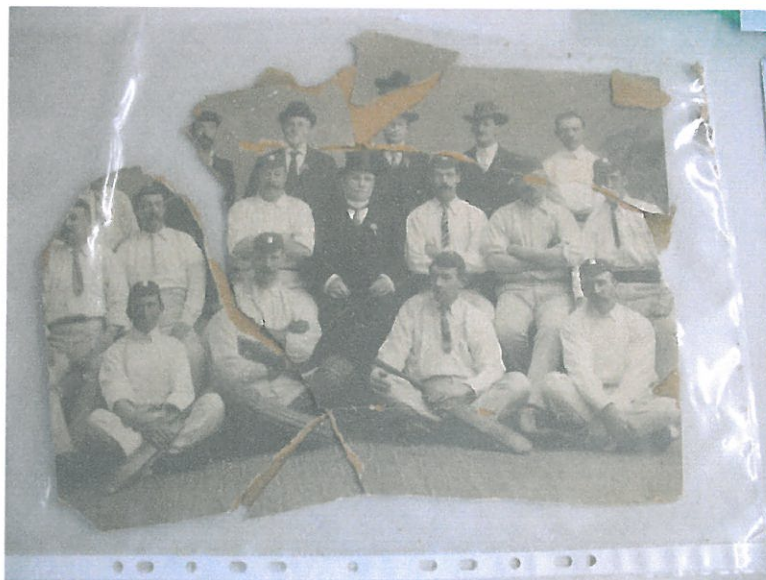
Photograph on acidic and brittle back board. Requires urgent conservation treatment

- **We recommend the photographs in storage and framed are an urgent priority for conservation, preservation storage and copying to digital or other media is highly recommended.**

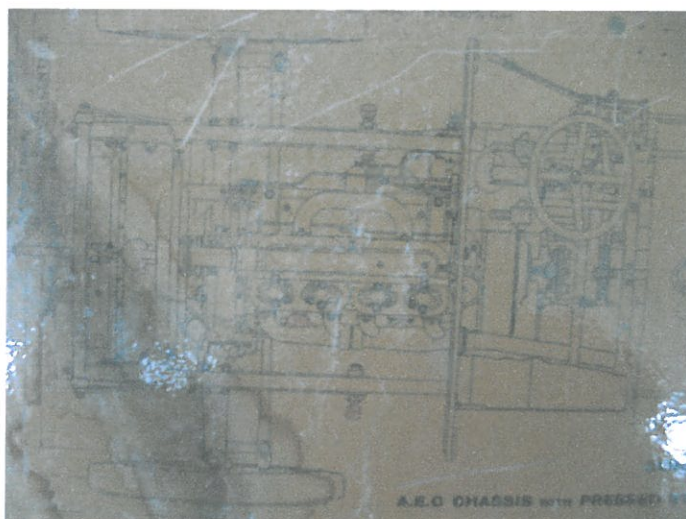
The photograph shows contact adhesive on design surface, previous water staining, glued to acidic board

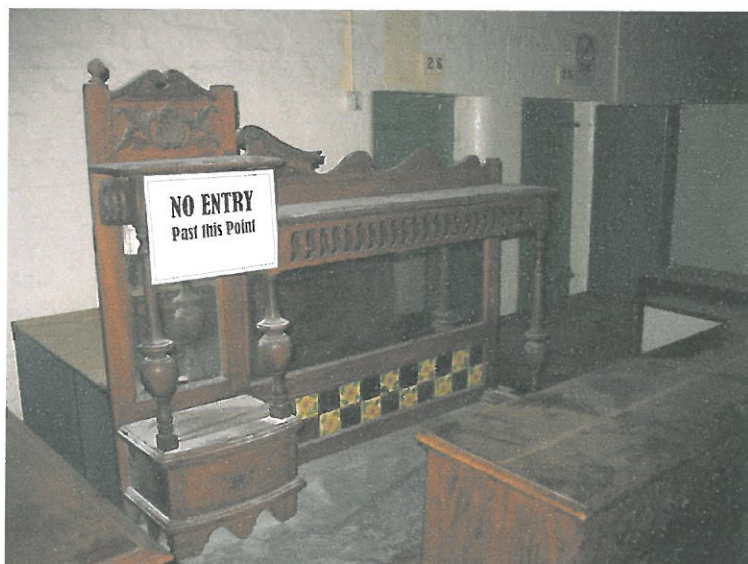
Photograph shows heavily dirt contaminated furniture in the cell storage area

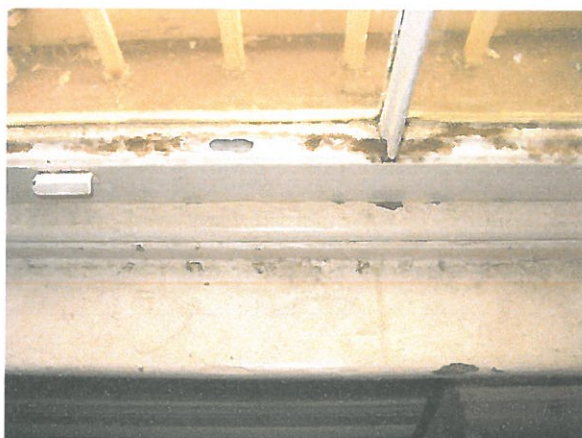
- We see **rot** in the internal and external timbers.
- All painted surfaces show signs of wear and weather attack.
- The paint is flaking and blistering off the timber in many areas both internally and externally.
- There is **rot** in the external side of the timber window sills and fascia boards.
- There is evidence of rising and falling damp in walls
- The slate roof is lichen and moss contaminated with rust in some areas and on down pipes.
- Air vents allow insects and dust to contaminate the building.
- The electrical wiring and switches in the building are old.
- The floor is uneven with heavily dirt contaminated carpets upstairs.

Damaged paint surfaces on timber windows, external rot, water penetration.

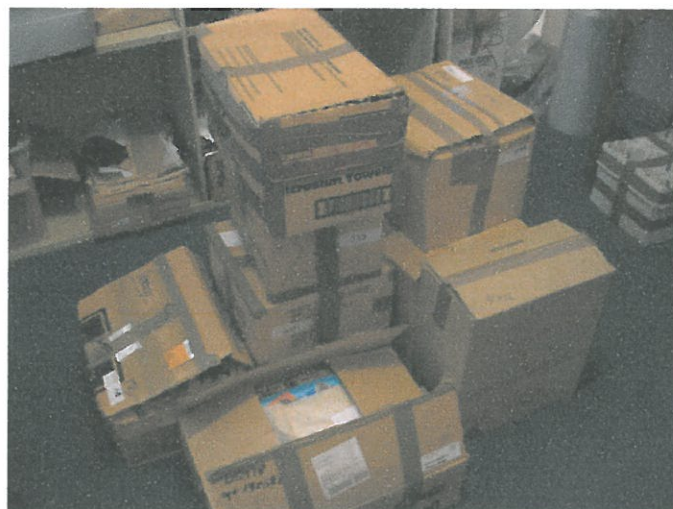
Approximately 90% of the collection is stored in **non archival cardboard boxes** which sit on the floor in the Governor's residence and cells and on some shelving. Most of these boxes are sealed with packaging tape and have some form of descriptive label or catalogue number on the outside.

A small proportion of the collection is housed in archival polypropylene boxes or in the case of some photographs polypropylene or polyethylene sleeves.

Thousands of items are stored in non-archival cardboard boxes, mostly corrugated cardboard produce boxes.

These boxes are **not suitable enclosures** for the long-term storage of book and paper based archives and they will have a direct effect on the deterioration of the items held inside them.

- Most boxes opened were filled to capacity with items causing compression damage. Boxes should never be filled to full capacity as the resulting weight can also make retrieval very difficult resulting in paper tears.

Hundreds of boxes sat in **direct contact** with the floor. In the case of boxes in the cell area, these would be absorbing moisture from the concrete floor thus making the items held susceptible to mould contamination and water damage.

The box should be larger than the item housed so as to provide adequate protection from dust, sunlight, insect and impact damage. Additionally any material in contact with the books should be of an **archival museum quality**. This reduces contamination of the stored items.

- **In order to protect the collection from possible mould and water damage it is strongly recommended to store all items off the floor by at least 100mm.**
- **A temporary measure would be to place boxes on a vapour barrier to the floor such as builders plastic.**

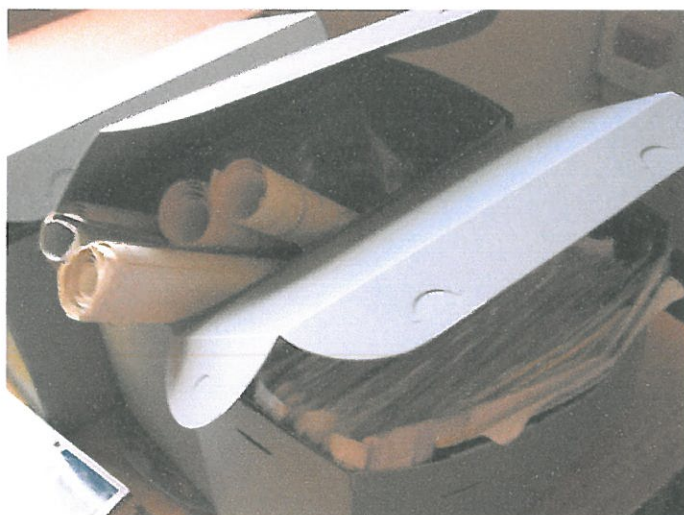
Too full boxes

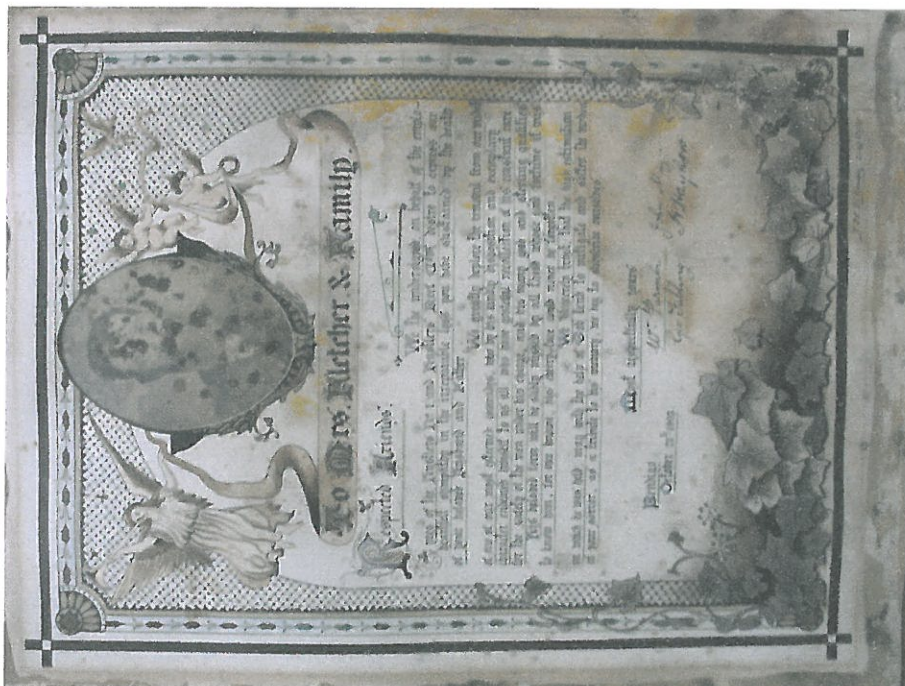
Water damaged illumination showing mould and acid burn. This item requires full conservation treatment and a specialised storage enclosure.

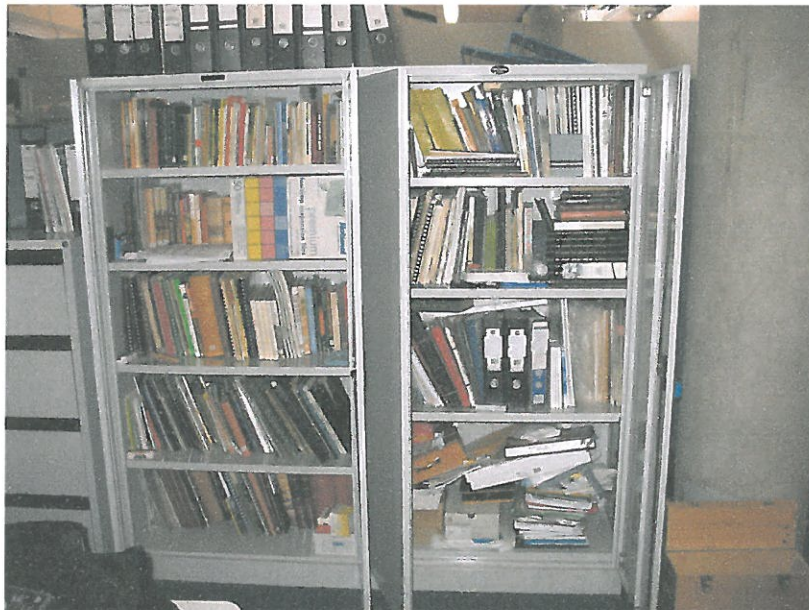
This photograph shows metal cupboards in the Bendigo Library housing reference books and some archives. Note shelves with items stacked in an ad hoc way causing compression damage to items held.

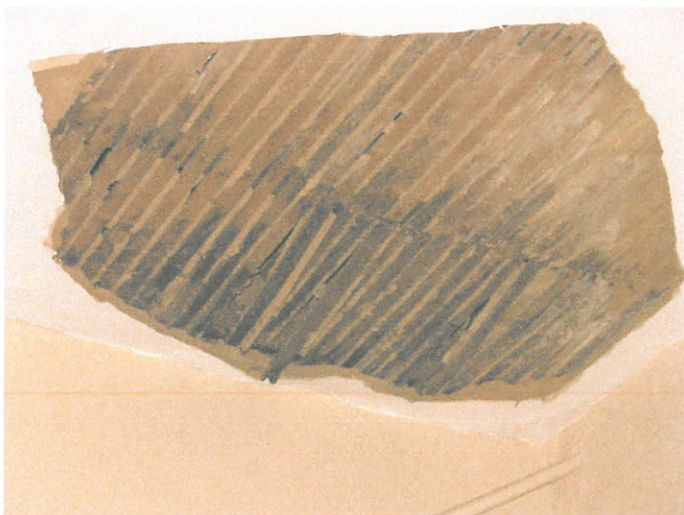
- **The greatest danger to the general collection is damp and raised R.H. levels due to the nature of the heritage building, especially during winter and spring.** We noted previous water penetration in all buildings.

Partial ceiling collapse in Governor's residence storage area through water penetration

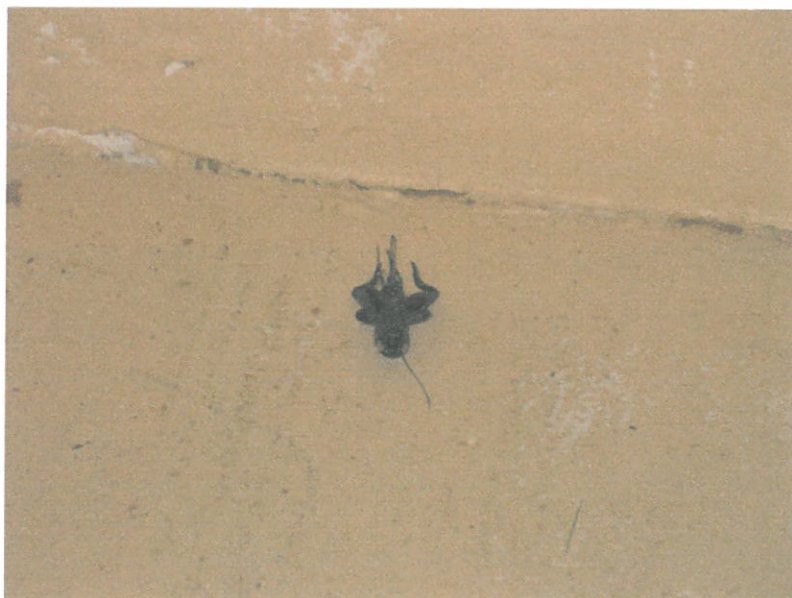
One of several insects found in the collection, most prevalent were silverfish.

It is necessary that an integrated pest management system be adopted. Such a system will include fortnightly vacuuming of the floors and shelves as well as the use of sticky insect traps.

- **The books or other items in storage should not be fumigated by pest controllers as this can cause major damage to the collection.**
- The installation of sticky insect traps is highly recommended. These sticky traps should be placed on each shelf in dark places and spaced every 2 metres.
- A surface insect spray applied every 3 months at the floor /skirting board area may also assist in the control of crawling insects.
- **Do not spray the surface of bindings, paper based material or objects.**
- Vacuuming on a fortnightly basis is required to control the dust contamination.

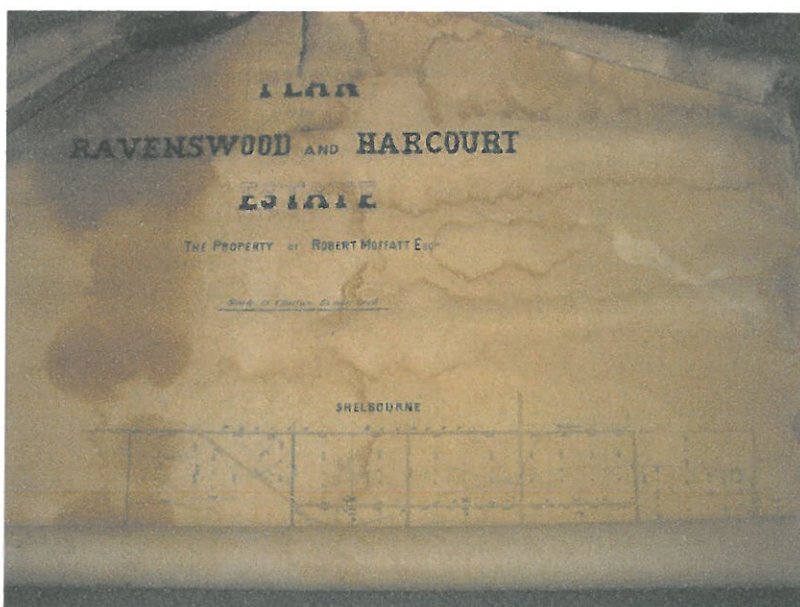
Water damage to map caused by poor housing and handling of the item.

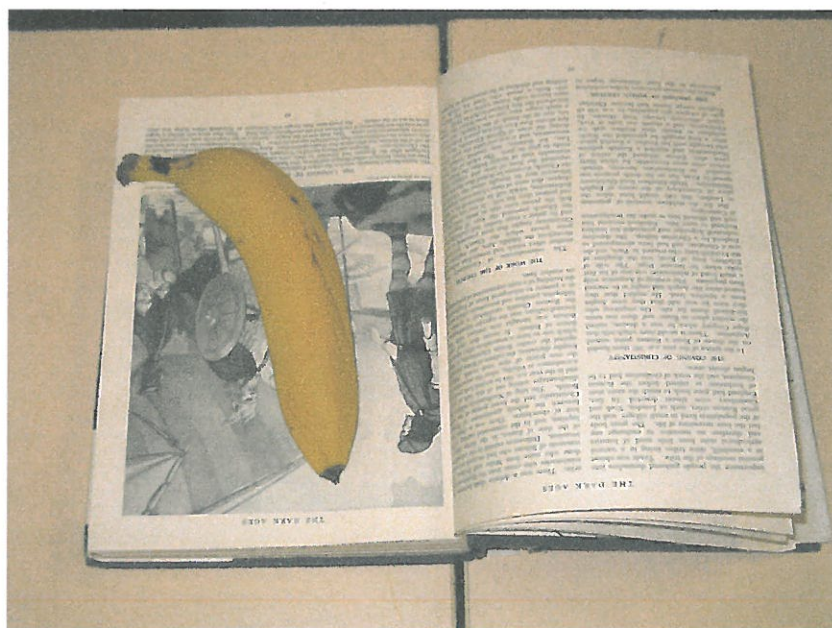
Banana used to hold open a book from the collection while being catalogued

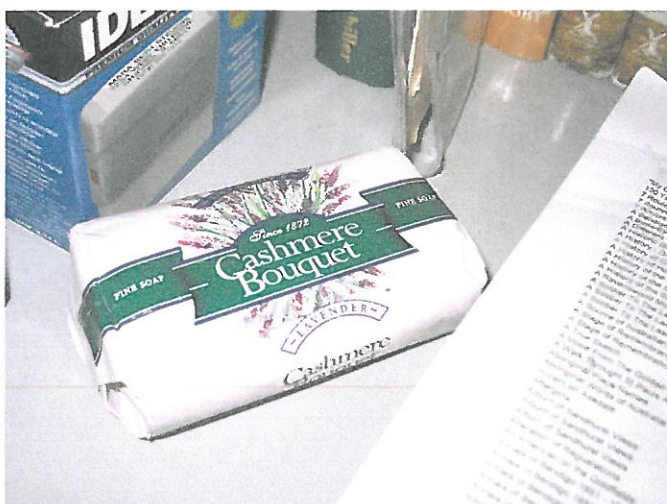
Pest control, a quaint but unproven method to control silverfish. Sticky insect traps are the preferred method.

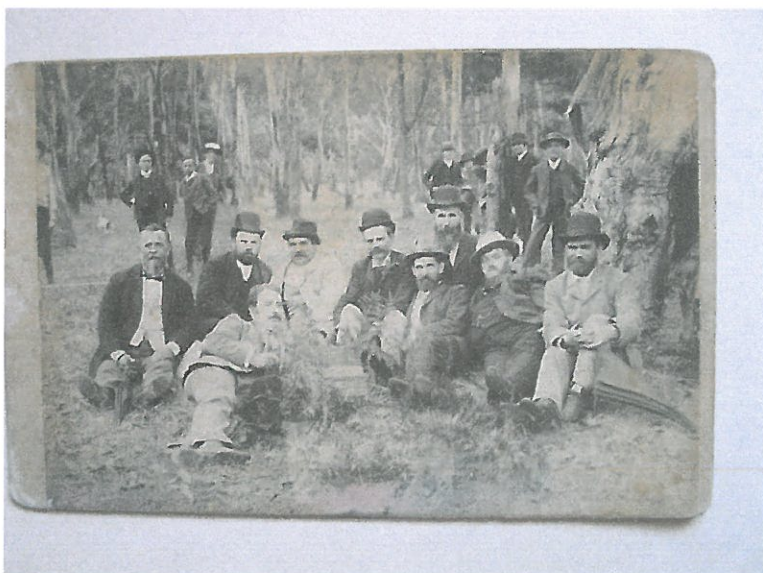
Albumen photograph

C1870 requiring removal from board, cleaning and emulsion consolidation. Over 800 items are in this condition and require urgent conservation treatment.
